Late-onset deep mesh infection after inguinal hernia repair

Volkan Genc, MD, Zafer Ergül, MD, Alper Yavuz, MD, Hakan Kulacoglu, MD, FACS

Diskapi Teaching and Research Hospital, Department of Surgery, Ankara, Turkey

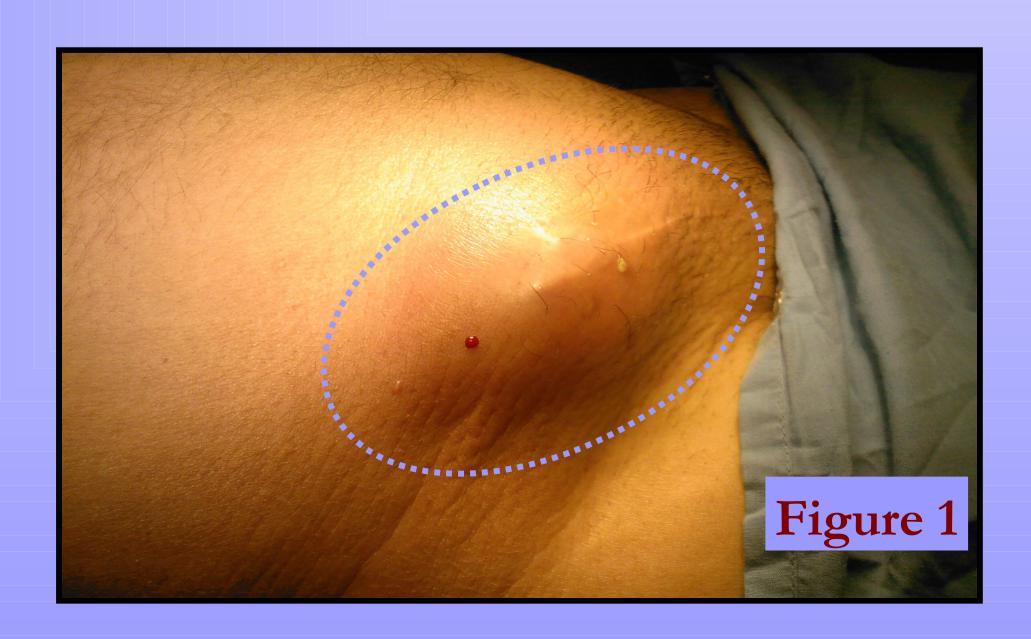
Figure 1: The gross view of swelling.

A 65-year old male patient admitted to hospital with general fatigue, inguinal swelling and local hyperemia. He had an open inguinal hernia repair with polypropylene mesh for a right-sided indirect inguinal hernia sixty-one months ago. In physical examination, the patient had a normal temperature and multiple palpable inguinal lymphadenopathies. The swelling was firm and painful, and the overlying skin was red in color (Figure 1). There was a mild leukocytosis with a sedimentation rate of twice its upper limit. Ultrasound showed a 31x12 mm cavity which contained fluid like hypo-anechoic pus. Abdominal-pelvic computed tomography demonstrated a pre-peritoneal mass closely adhering to the small bowel (Figure 2). Eventually, pus was drained surgically and the mesh was removed (Figure 3). The wound was left open for secondary healing. Methicilline resistant staphylococcus aureus was isolated from culture. The wound was irrigated with saline and dressed with antibacterial pomade daily. The wound completely healed at 2 months. No sign of hernia recurrence was detected.

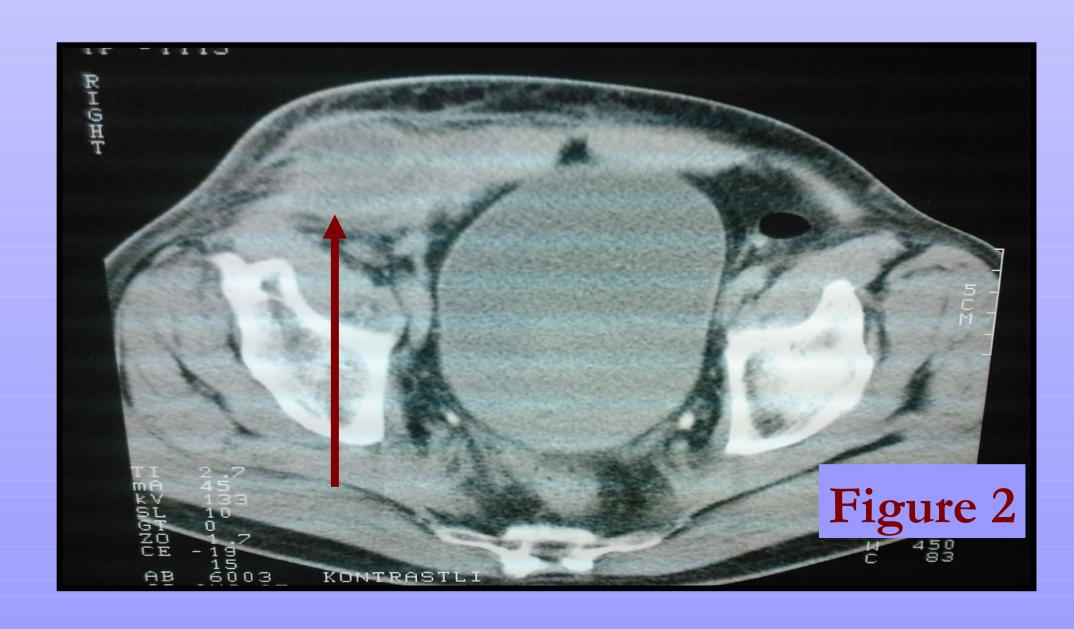
Figure 2: CT shows a preperitoneal mass about 3 cm in diameter.

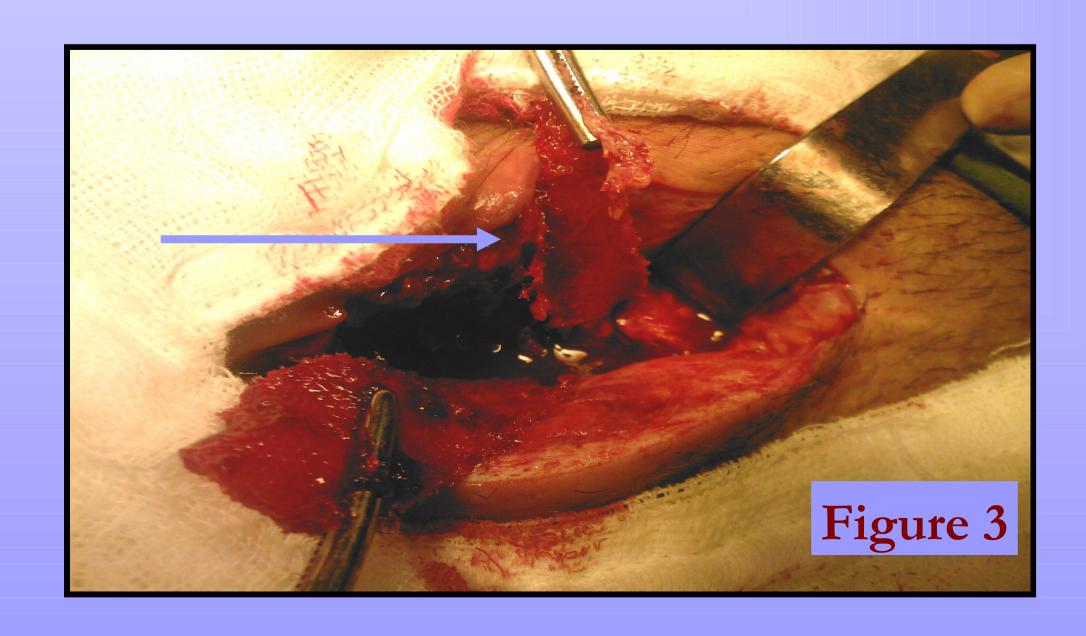
Figure 3: Intraoperative photograph of meshoma.
